# **Fimiston Gold Mine Operations (Ministerial Statement 782) - 5 Year Performance Review**

2015-2019

March 2020

Project Number: TE19058

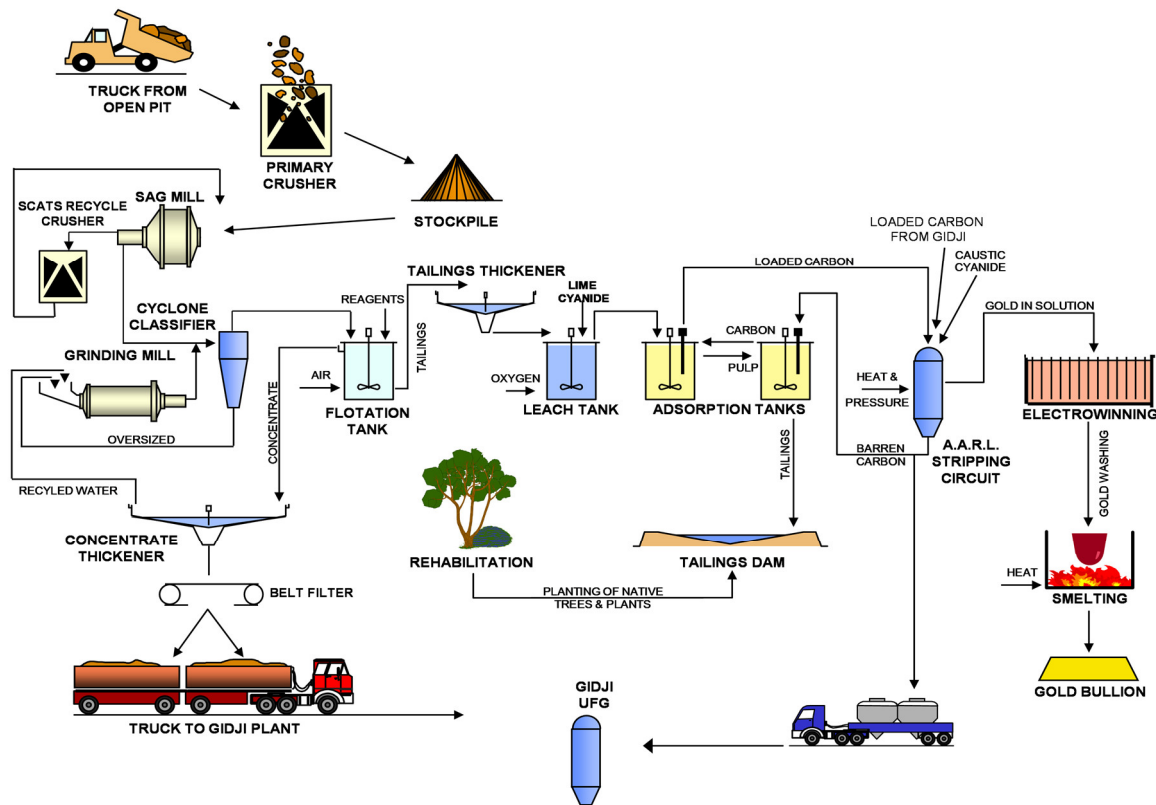
**Figure 2-2: Gold ore treatment flowchart**

Gold is generally present as either free gold, within telluride minerals, locked in pyrite or silicate minerals. Ore is ground to liberate the pyrite in preparation for the ensuing processes. In the flotation circuit the gold bearing refractory sulphide is separated and referred to as concentrate. This concentrate is de-slimed, and the slimes are subjected to flotation to recover any coarse sulphide particles. The slimes flotation tailings (SFT) are treated at Fimiston in one of the CIL circuits, CIL1.

The de-slimed concentrate and slime sulphides are combined and classified into two streams. One stream is washed, filtered and transferred to Gidji for further treatment. The other stream is directed to an Ultra-Fine Grinding (UFG) circuit at Fimiston. The UFG circuit reduces the particle size of the concentrate to facilitate acceptable cyanide leach recoveries; this material is combined with the SFT. Flotation circuit tailings are further treated on site in two of the CIL circuits, CIL2 and CIL3. Final tailings are pumped to the TSFs.

The processes undertaken in the Fimiston Processing Plant are outlined below and shown in **Figure 2-2**:

- Two crushing circuits that supply coarse ore as a mill feed stockpile;
- Two milling circuits, the Fimiston and the Mt Charlotte. The Fimiston circuit comprises a semi-autogenous grinding (SAG) mill and a pebble crushing circuit with two secondary ball mills and four Knelson concentrators. The Mt Charlotte circuit is a single SAG mill and ball mill with a single Knelson concentrator;
- A flotation circuit and three carbon-in-leach (CIL) circuits through which milled ore is processed;
- Filtration and Ultra Fine Grind (UFG) via a carbon in leach circuit through which flotation concentrates are de-slimed and processed;
- A gold recovery circuit comprising an Acacia reactor, elution, electrowinning, smelting, pouring and production of gold bullion; and
- Tailings storage facilities (TSFs).

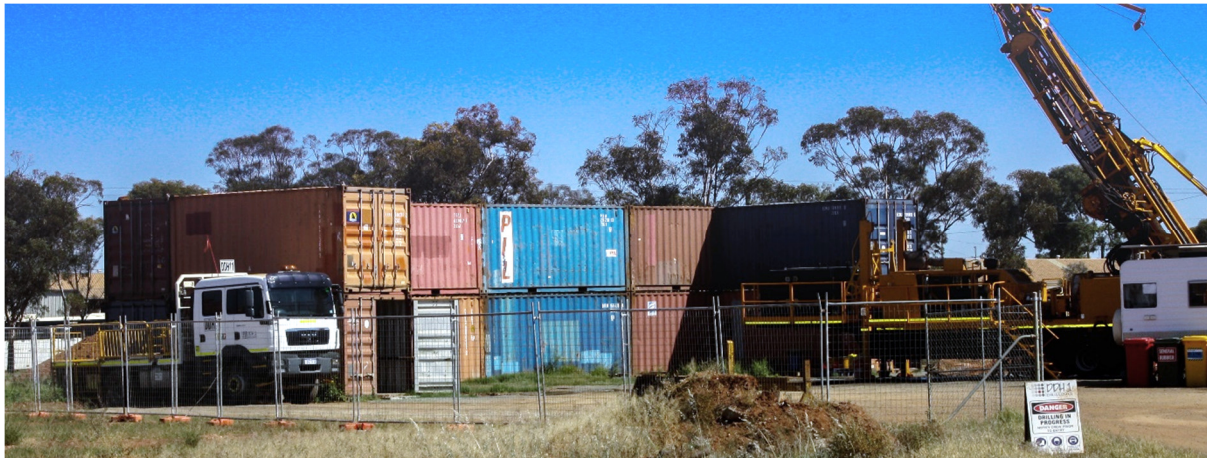
**Plate 5-1: Noise barrier to reduce noise from drilling activities at sensitive receptors**

- Restrictions on the use of certain equipment to daytime only;
- The use of high intensity magenta strobe lights on the ROM pad in lieu of a reversing alarm;
- The use of 'broadband' reversing alarms that produce a less tonal noise than traditional 'beeping' alarms on mining equipment;
- Adjustments to conveyor maintenance procedures; and
- The use of screening using sea containers (**Plate 5-1**) to reduce noise emissions from exploration drilling activities when operating in close proximity to the community.

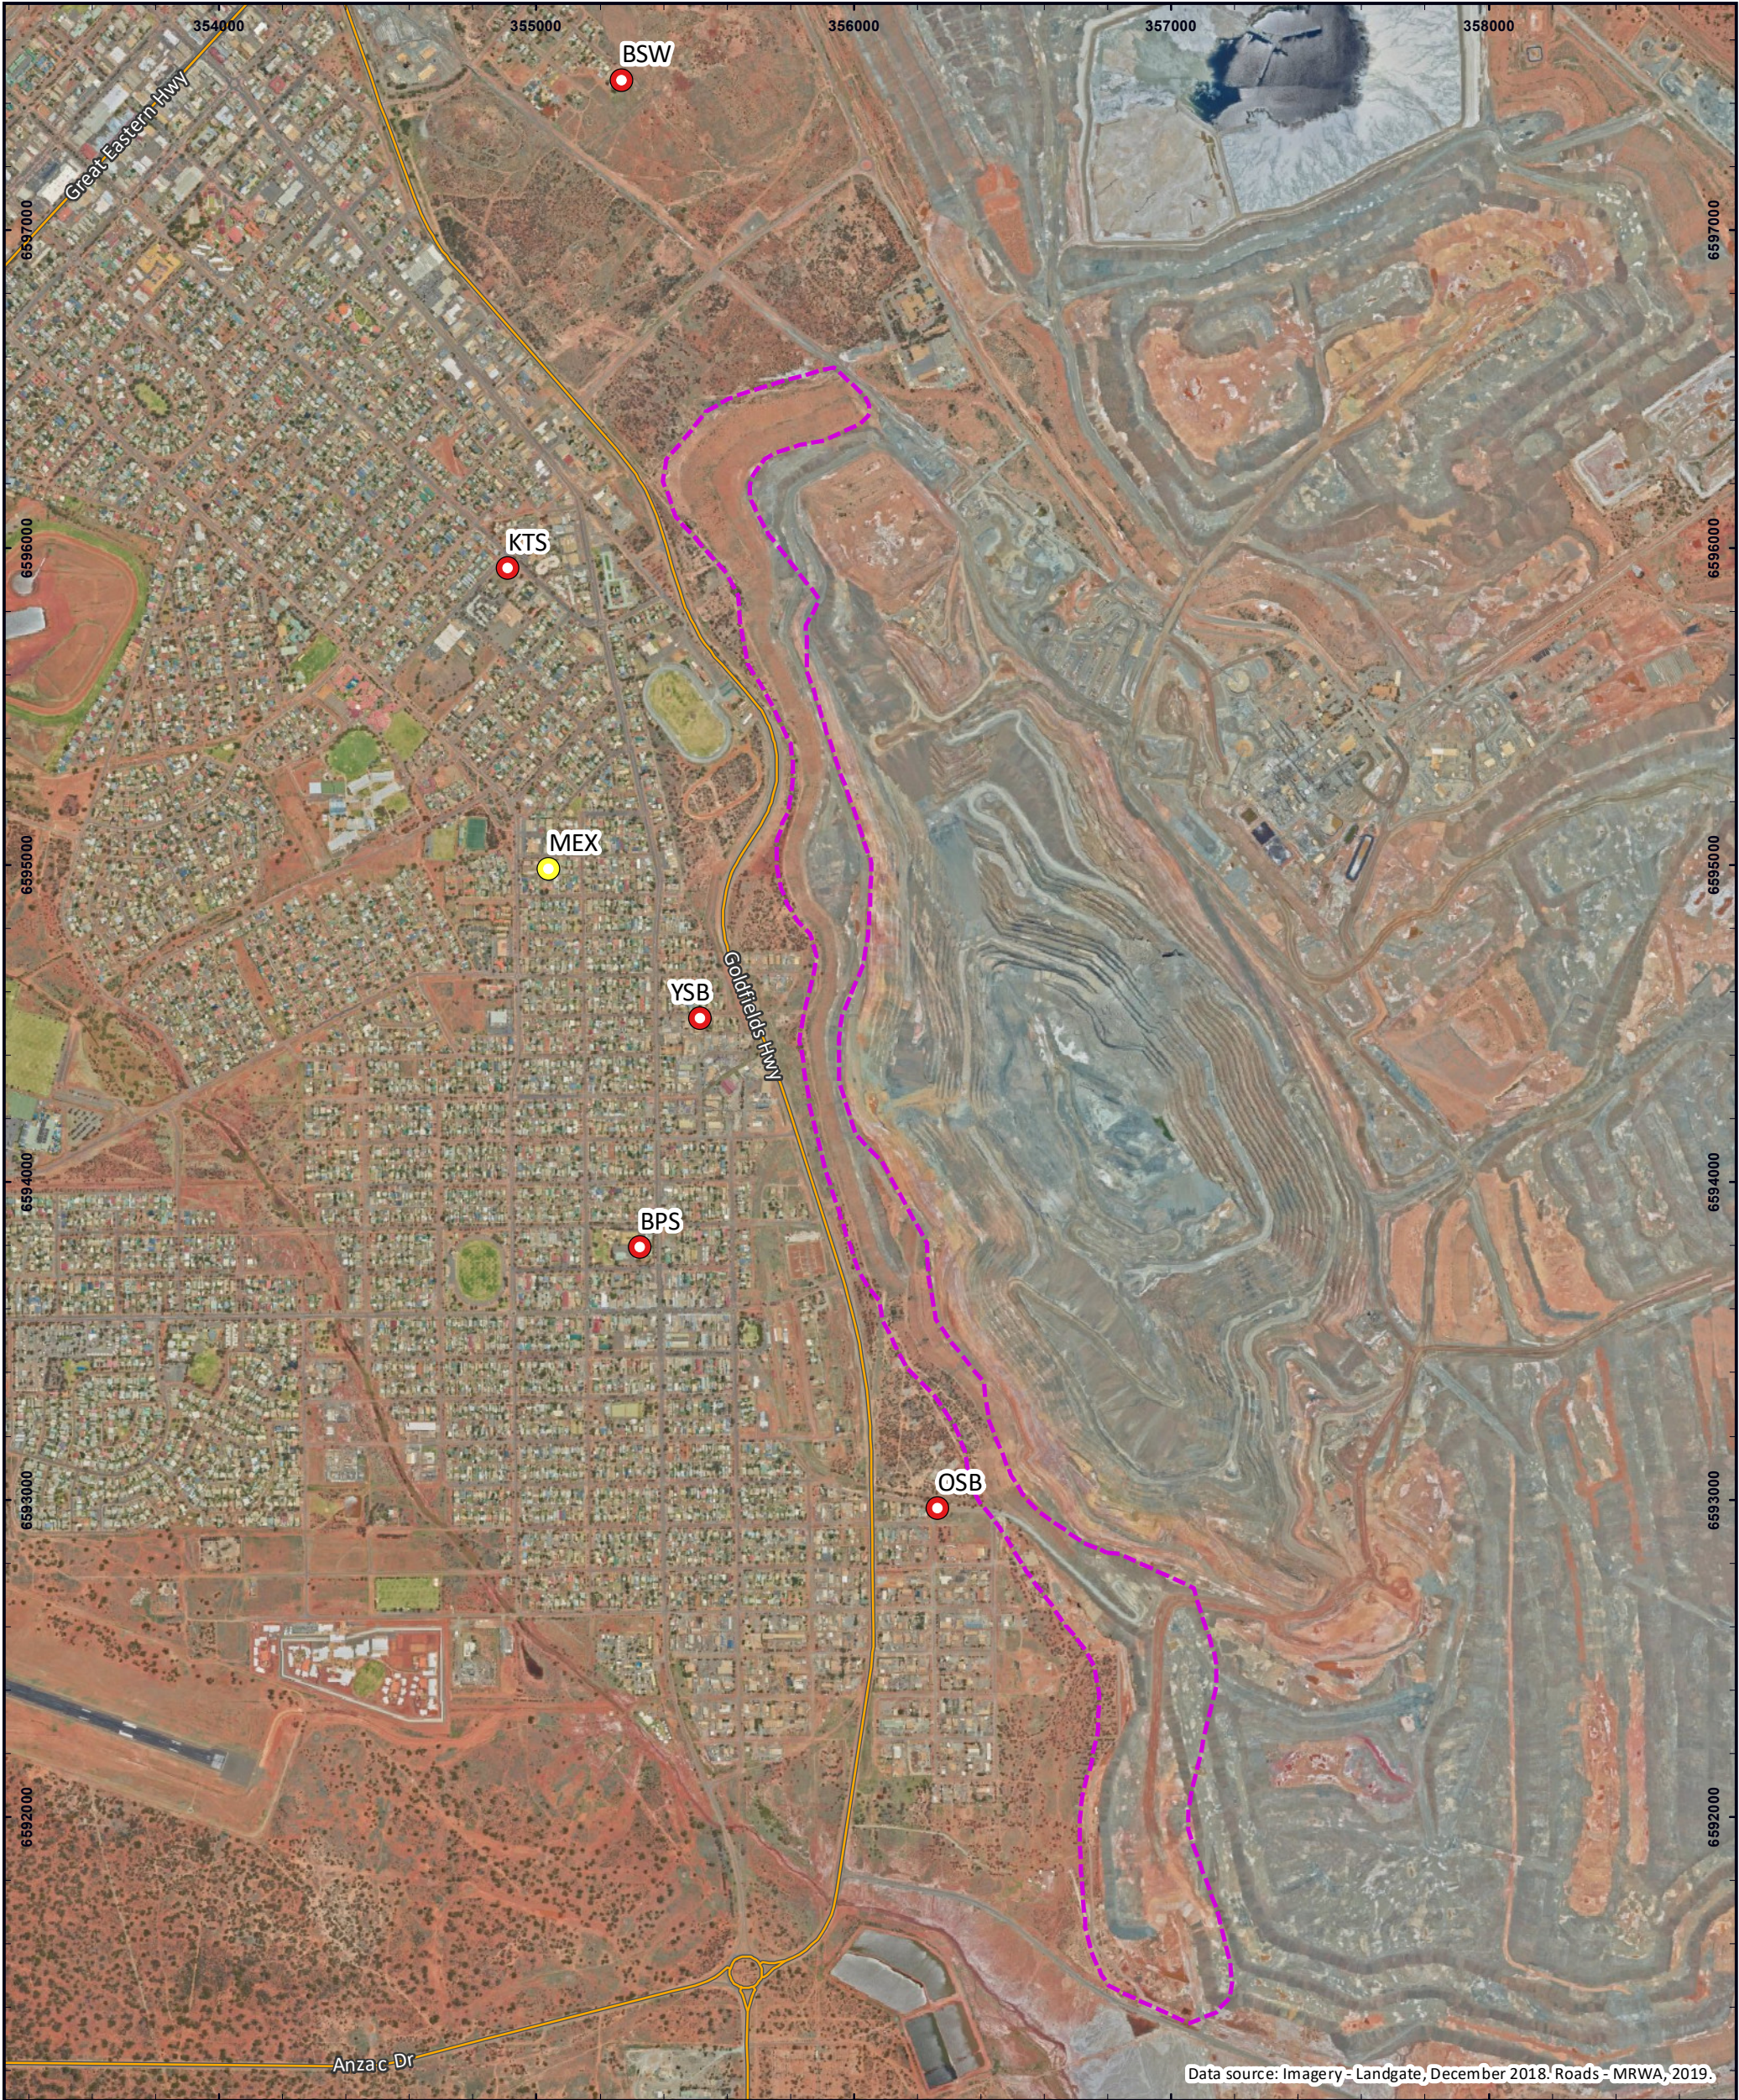
**ENVIRONMENTAL NOISE  
MONITORING LOCATIONS**

Compliance noise monitoring is undertaken each quarter by specialist noise consultants during the evening and/or night periods to minimise the sources of contributing noise other than mining (i.e. traffic), and also as it represents the time of day that Kalgoorlie-Boulder residents are likely to be most affected by mining noise from the Fimiston Operations. These results have been provided to the DWER in the Quarterly Noise and Blast Reports and to the community in the newspaper advertisements and via the KCGM website.

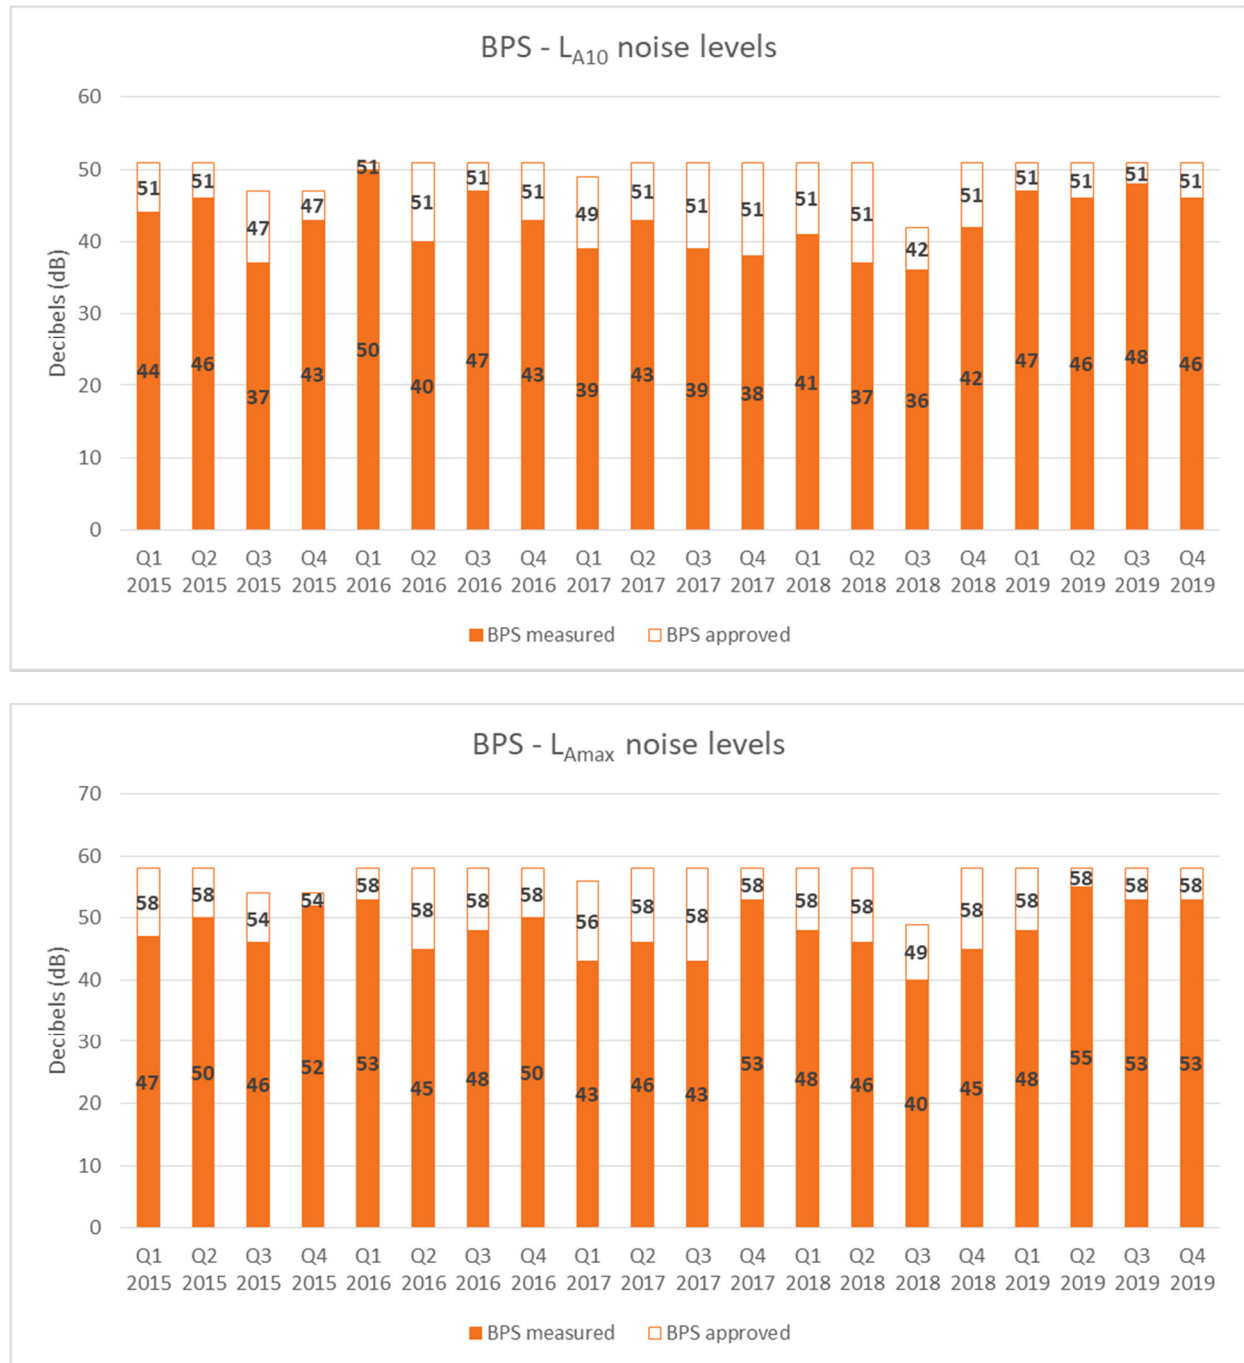
**Figure 5-2: Boulder Primary School (BPS) – compliance noise monitoring –  $L_{A10}$  and  $L_{Amax}$  noise levels**

For the five year review period, the noise levels measured at the five reference locations have all complied with the key performance indicators (the approved noise levels for the evening/night time period) (see **Figure 5-2** through to **Figure 5-6**).

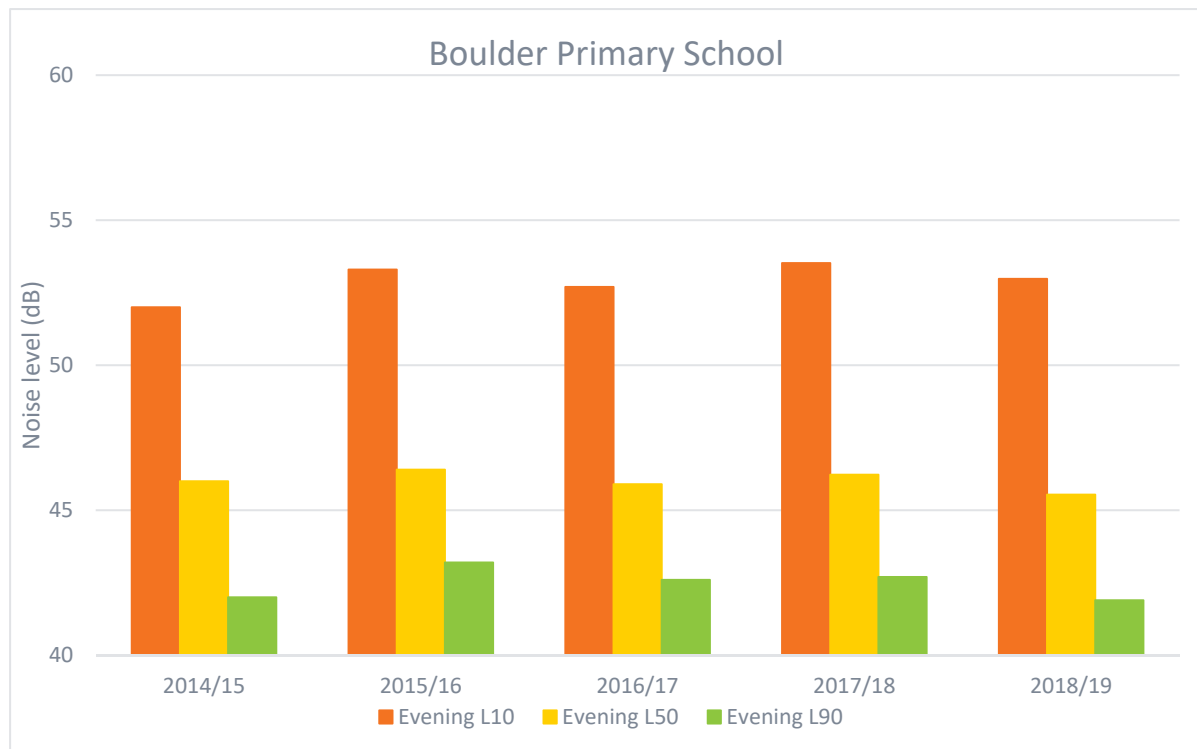
**Figure 5-7: Boulder Primary School (BPS) - continuous noise monitoring 2014/15 to 2018/19 (evening).**

Continuous noise monitoring is also undertaken. While not required for compliance purposes, it provides a reference for the comparison of noise levels over time. It is not a reliable indicator of noise from the mine as it also records noise from a range of other sources from the residential area e.g. traffic, workshops etc. There are no key performance indicators that apply.

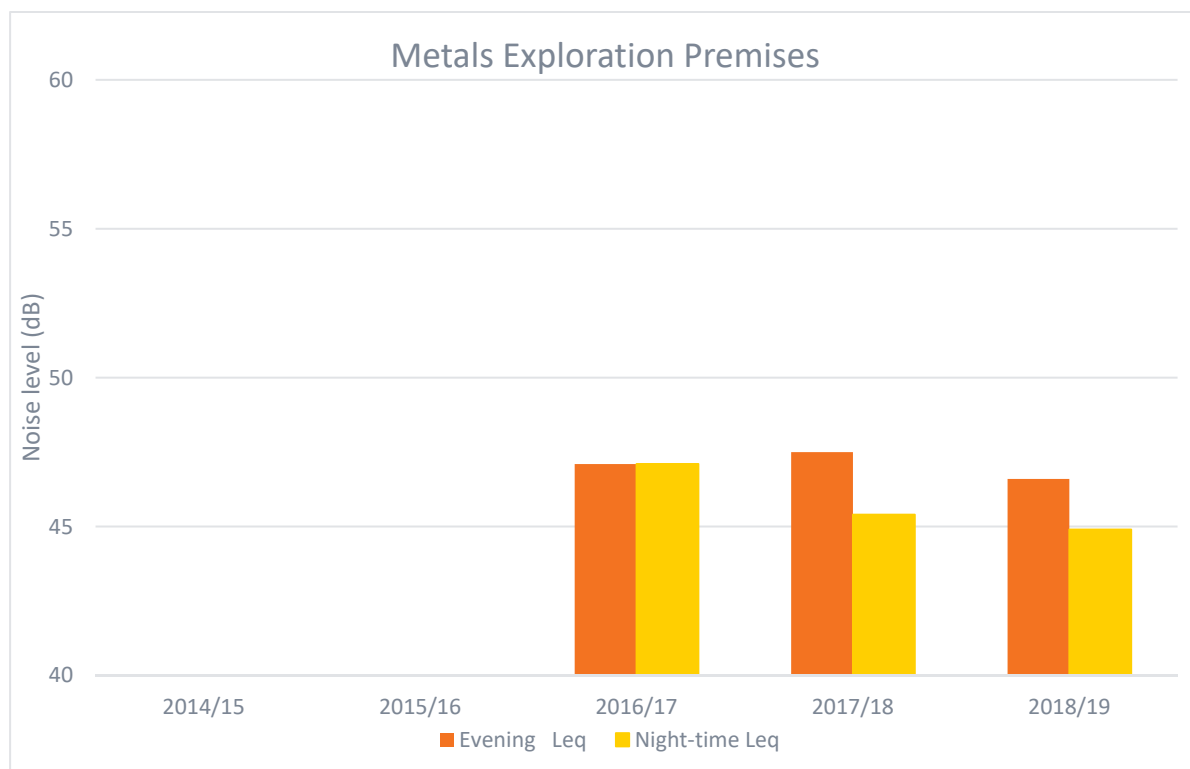
**Figure 5-11: Metals Exploration Premises (MEP) - continuous noise monitoring 2016/17 to 2018/19 (evening and night-time).**

<sup>1</sup> The 2016 Fimiston Noise Approval replaced Kalgoorlie Technical School (KTS) with Metals Exploration Premises (MEP) as a continuous noise monitoring site, as of the 22 March 2016; however, KCGM continued to record continuous noise data at KTS until 30 June 2016.

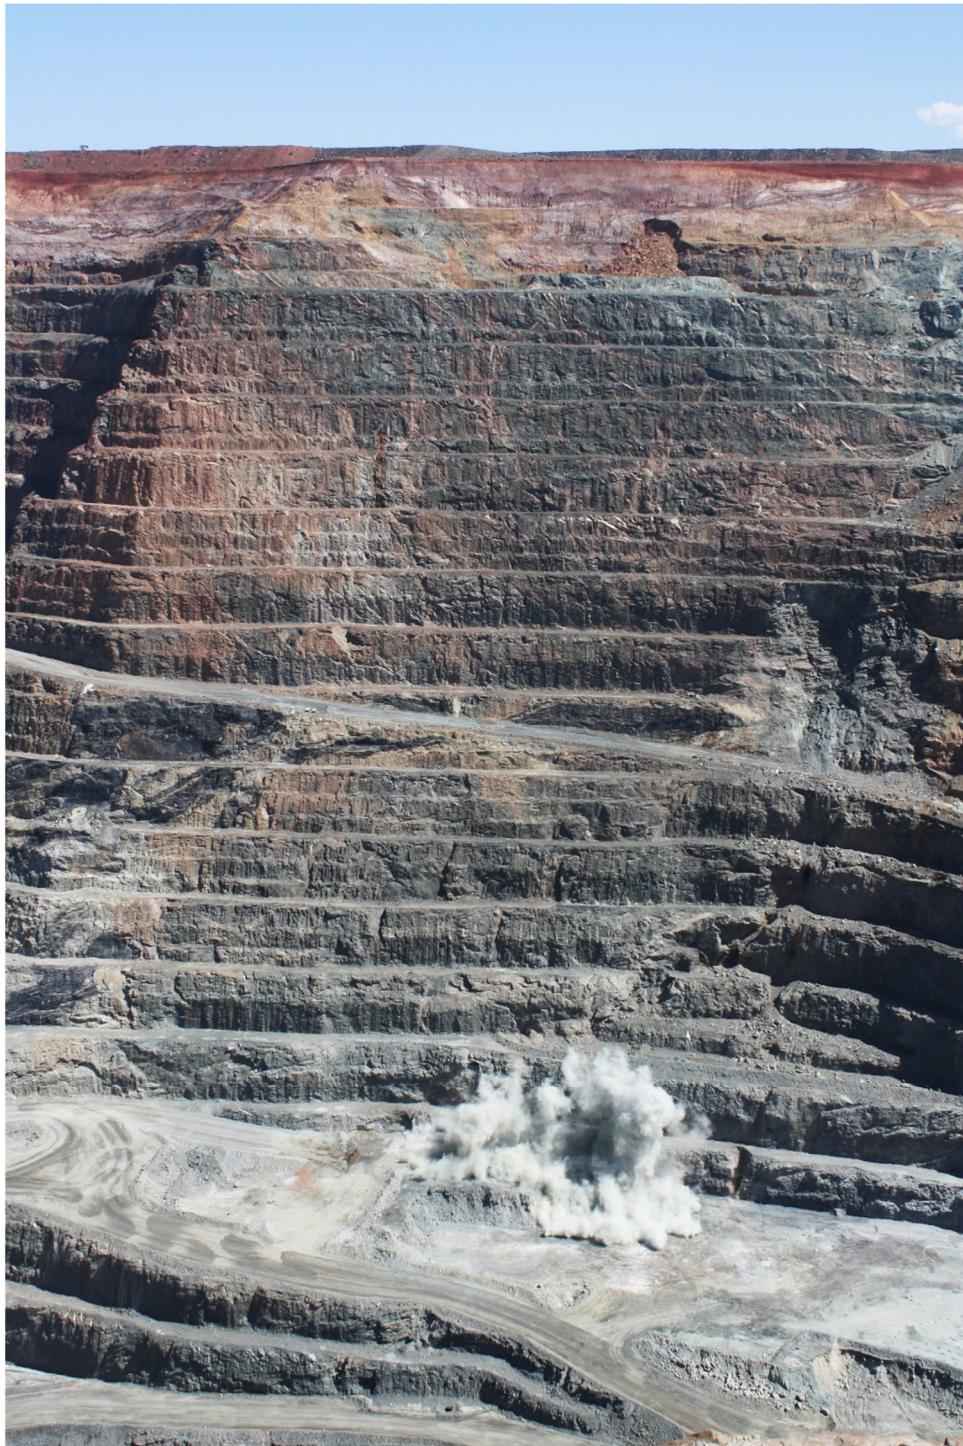
**Plate 5-2: Fimiston open pit blast**

Blasting (**Plate 5-2**) creates an airborne shock wave ('airblast'), which is measured in  $L_{Z\ peak}$  (the peak sound pressure level in decibels (dB) obtained using the "Z" frequency weighting characteristic). Monitoring of airblast is undertaken at six locations (see **Figure 5-12**).

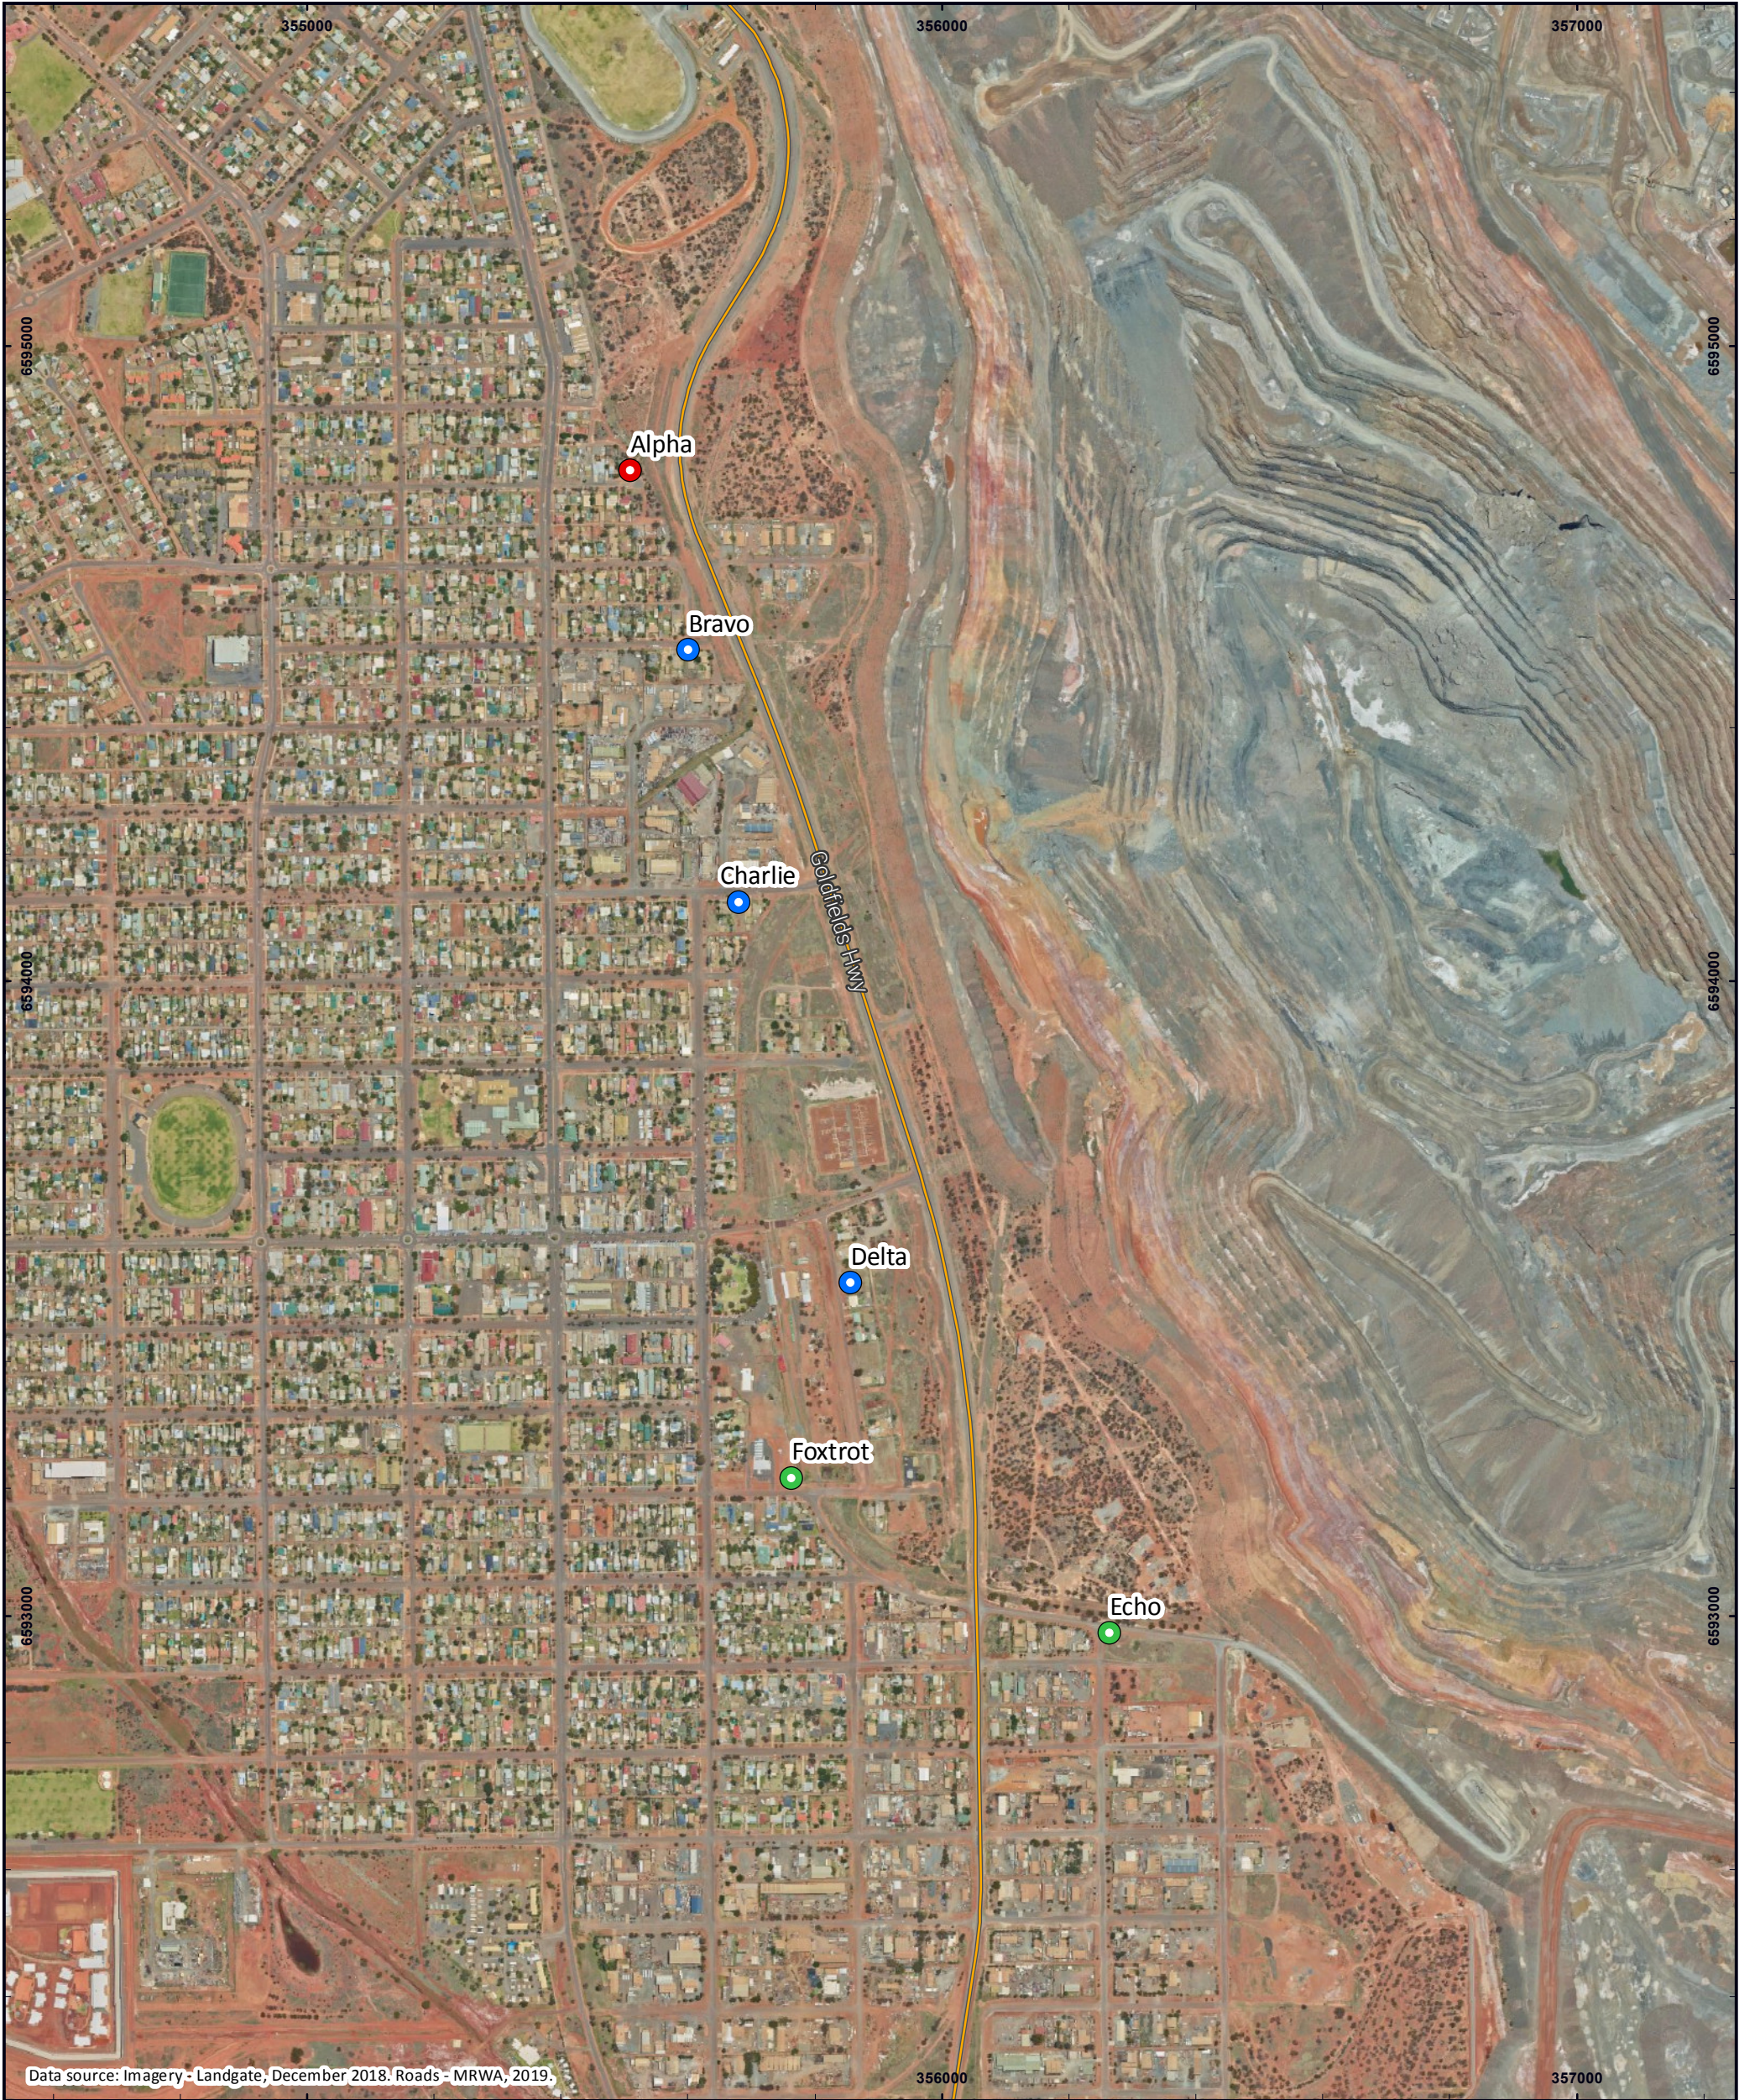
**AIRBLAST AND VIBRATION  
MONITORING LOCATIONS**

Blasting also causes ground vibration, which is measured in terms of peak particle velocity (ppv) in mm/s. Monitoring of ground vibration is undertaken at six locations (see **Figure 5-12**).

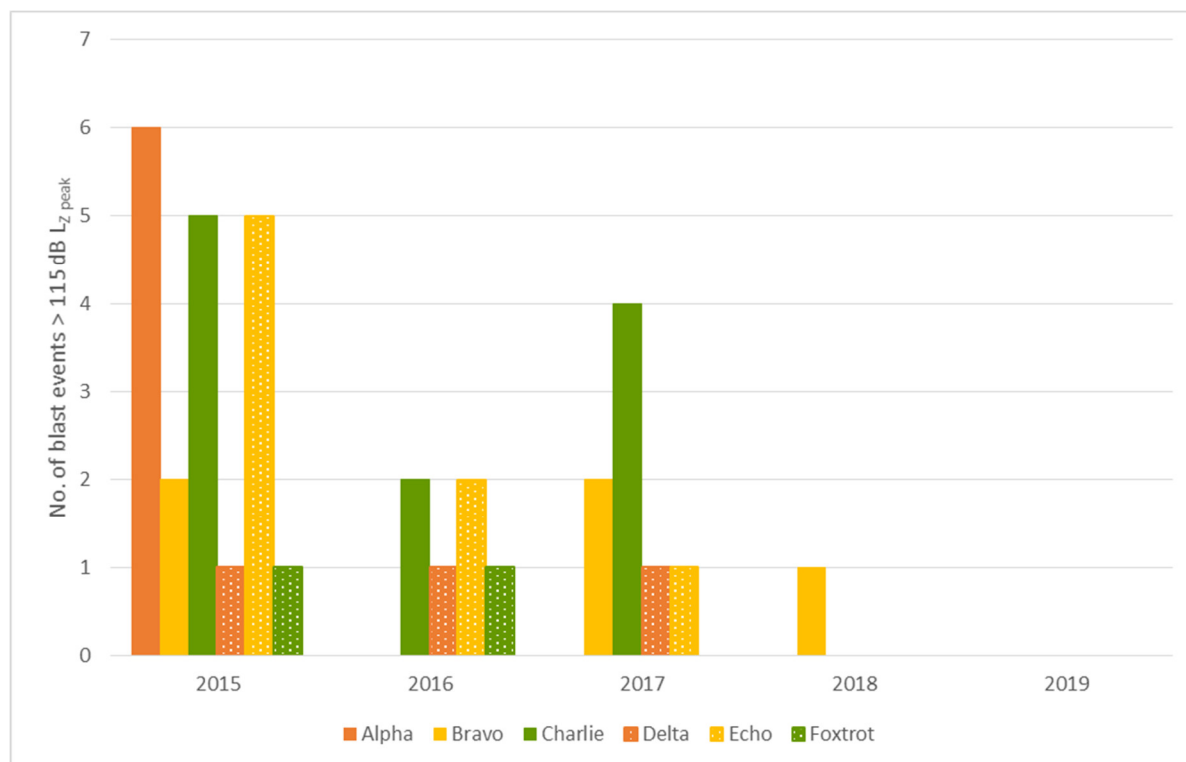
**Figure 5-13: Airblast monitoring - number of blast events where airblast levels > 115 dB  $L_{Z\ peak}$  were recorded**

The number of blast events where the airblast level exceeded 115 dB  $L_{Z\ peak}$  is shown in **Figure 5-13**. Levels declined significantly over the reporting period with no blasts exceeding 115 dB  $L_{Z\ peak}$  in 2019.

In terms of compliance, there was one occasion during the review period where KCGM was not able to comply with the key performance indicators for airblast. In Q1 2015, elevated airblast readings greater than the limit of 120 dB were recorded at monitoring sites Bravo (121.6 dB), Charlie (123.1 dB) and Delta (125.1 dB) and greater than the limit of 125 dB at monitoring site Echo (125.3 dB). Changes to blasting procedures resulted (see Appendix B for further information).

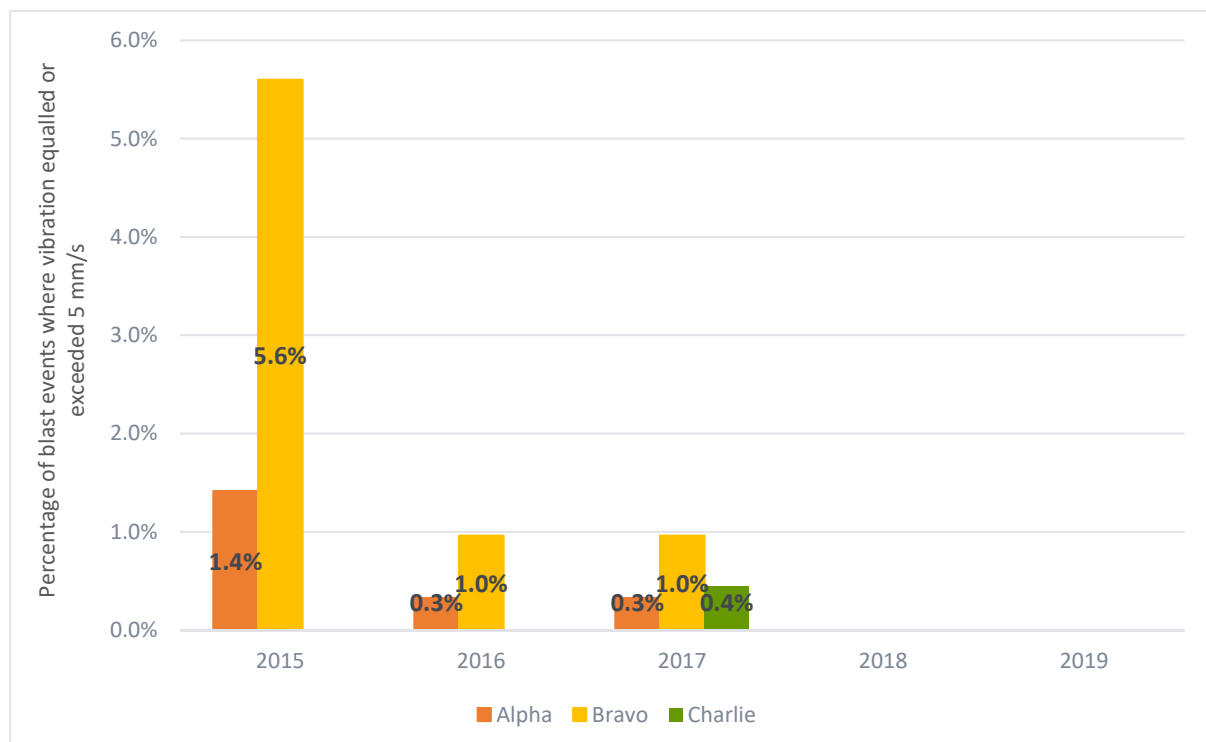
**Figure 5-14: Vibration monitoring – frequency of blast events where vibration levels of > 5 mm/s were recorded**

The percentage of blast events where the vibration level exceeded 5 mm/s is shown in **Figure 5-14**. No blasts exceeded 5 mm/s at the Delta, Echo and Foxtrot monitoring locations during 2015-2019. Levels declined significantly over the reporting period with no blasts exceeding 5 mm/s in 2018 or 2019 at any location.

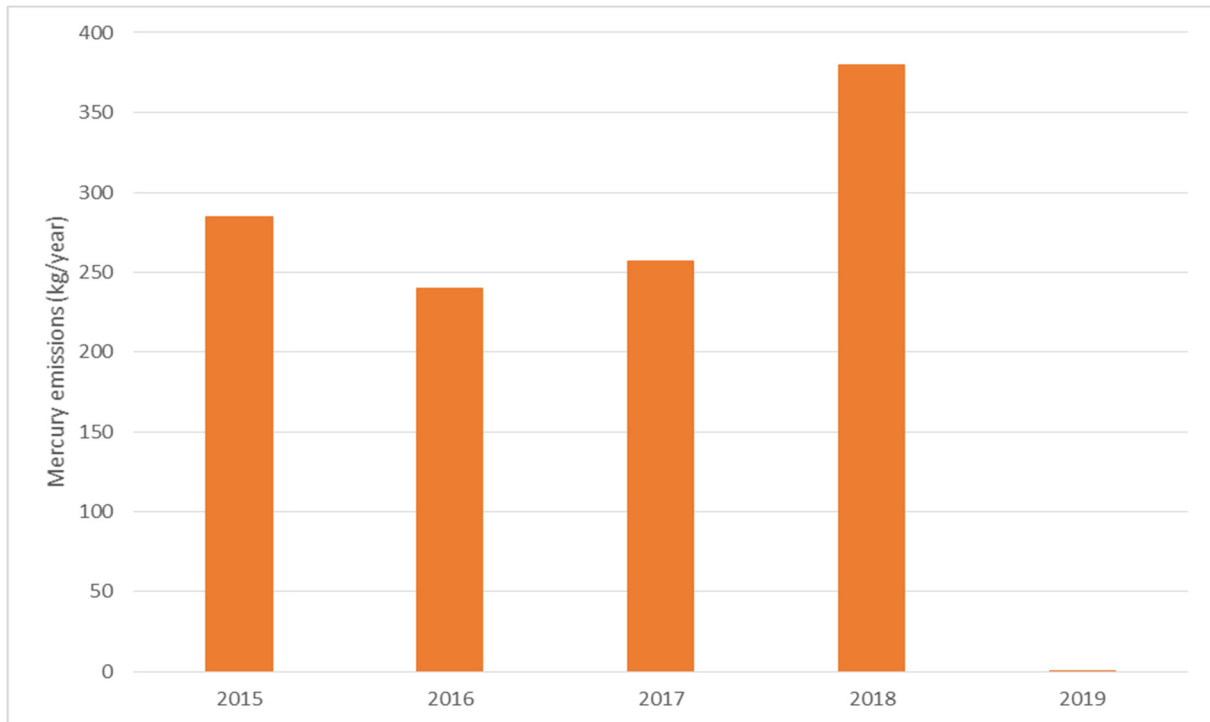
**Figure 5-24: Mercury emissions (kg/year) for the period 2015-2019**

In accordance with the FAQMP, mercury emissions from the carbon regeneration kilns are estimated via a mass/balance calculation and the data is submitted annually to the National Pollutant Inventory (<http://www.npi.gov.au/>). There is no target level of mercury emissions but, as outlined in the previous section, work has been underway in the Fimiston ERP to significantly reduce mercury emissions from the Fimiston Processing Plant. While commissioning is continuing, the mercury capture system is operational with emissions falling to close to zero, as shown in the following figure. While the emission loads are measured indirectly through calculations, the results are supported by stack testing.
